EARLY DETECTION OF DAMAGE IN HEAVY DUTY COMBUSTION TURBINE BLADES FOR ELECTRIC GENERATION

P. MAGNESCHI *, G. TIRONE *

PRESENTED BY: G. TIRONE PISA 27/9/2000

* ENEL PRODUZIONE S.p.A. TORINO - ITALY

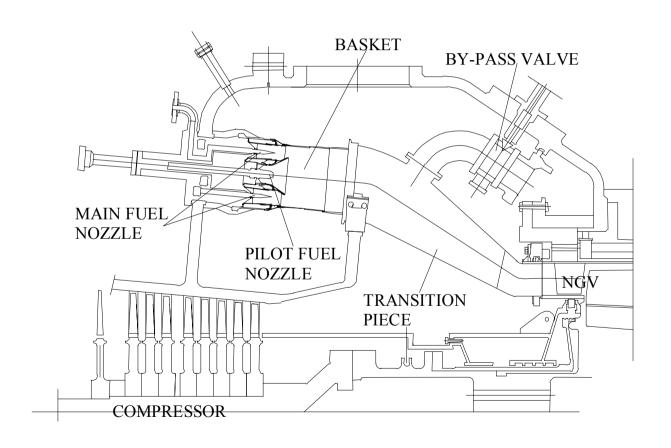
TYPICAL DLN COMBUSTION SYSTEM

- AFTERWARD THE INVESTIGATION WAS AIMED TO RESEARCH PECULIAR SERVICE CONDITIONS CHARACTERIZED BY THE PRESENCE OF ALTERNATING HIGH STRENGHT STRESSES
- DLN COMBUSTION SYSTEMS, IF NOT WELL SET, ARE ABLE TO PRODUCE LOW FREQUENCY (LOWER THAN 60 Hz) PRESSURE PULSATIONS WHICH MIGHT EXCITE NATURAL VIBRATION FREQUENCY OF DOWNSTREAM TURBINE BLADES

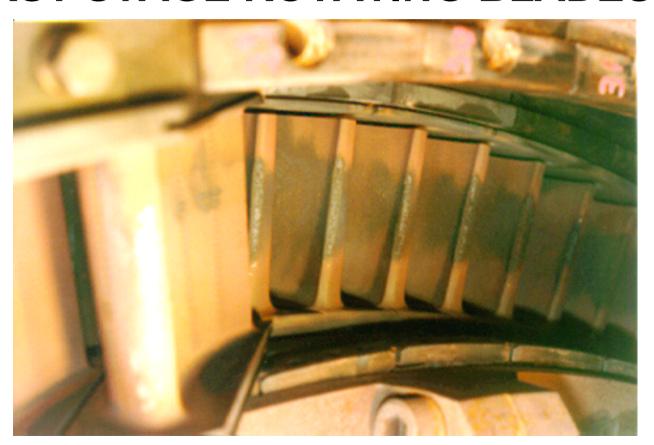
FIRST STAGE ROTATING BLADES

- 4TH ROTATING STAGE BLADE FAILURE
- 1ST ROTATING STAGE BLADE CRACKS IN THE PLATFORM
